First visit to the site showed that the hut was built a few years ago but was in a very bad shape

DAZDESIGN CONSULTANTS

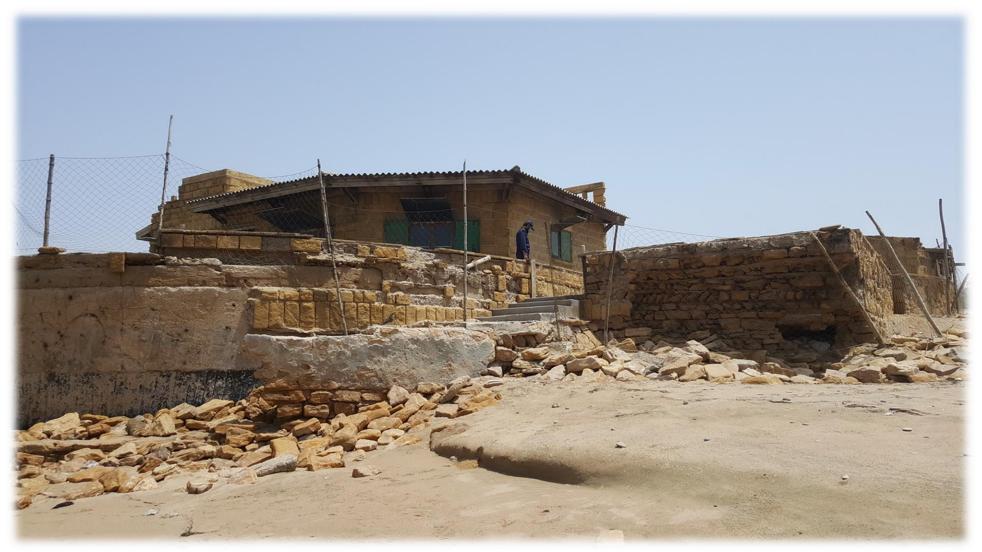
The basic structure was in place but the stone cladding had worn out considerably

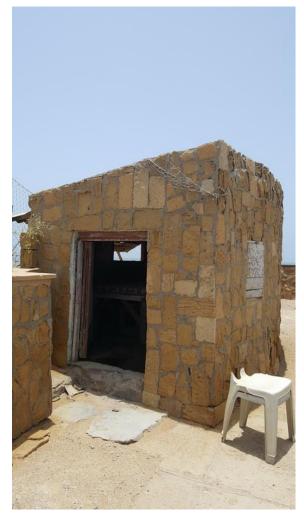
Most of the boundary wall of the hut was unfinished

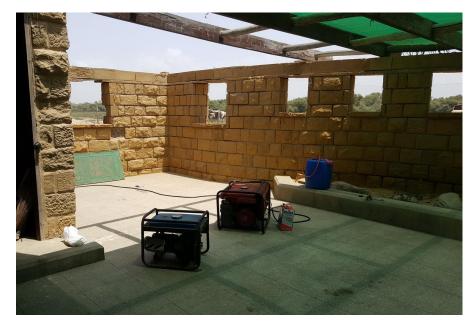
The entrance area had a typical green fabric shade

The green shade was removed from the entrance area with a new design introducing bamboo and 'Chikh' material

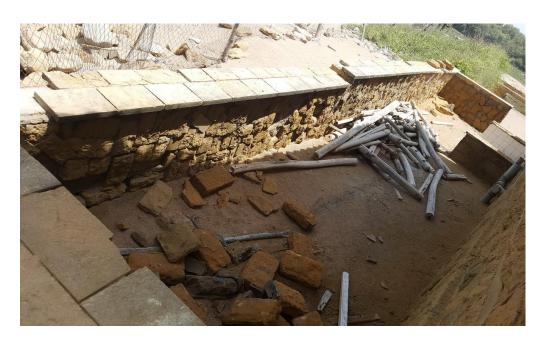
The BBQ area was never completed

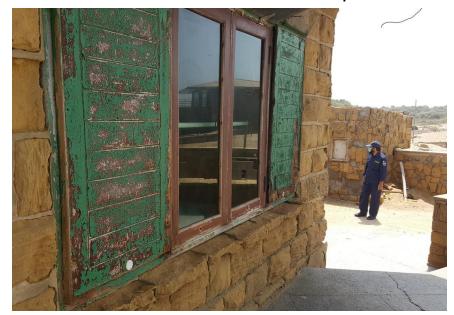
The timber work on the seaside was worst

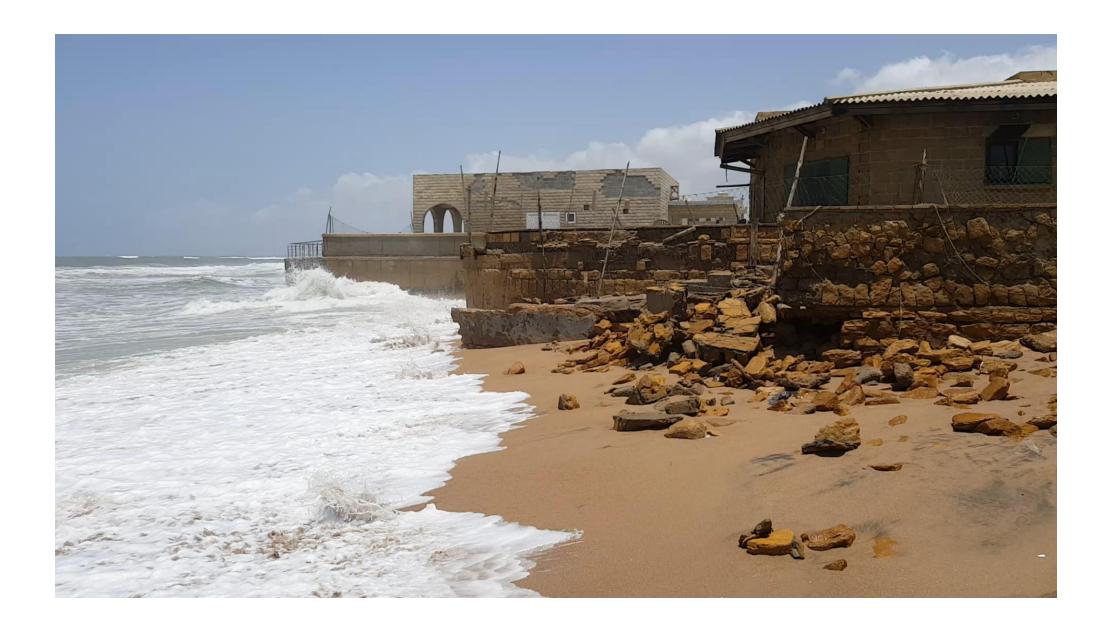
The real problem was in the seafront, where the sea was thrashing the hut with massive waves cutting through anything that came in the way

The sea water at times would flood the front deck and the compound area, despite the height of the deck

We proposed large stone boulders to be placed strategically in front of the hut to reduce the impact of the waves

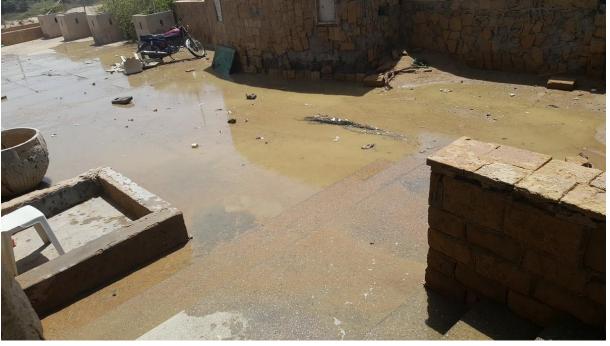
The waves had destroyed entire stone cladding on the hut. The materials crumbled under the might of the sea water

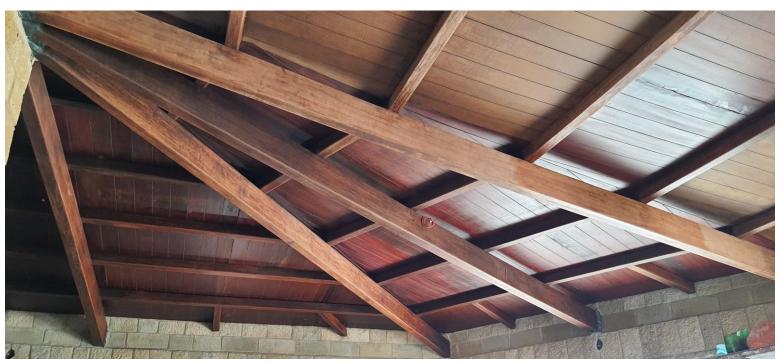
Next we took all the widows and woodwork. The RCC lentils were cracking, Sills were worn out, they were all replaced with Silbatta Stone

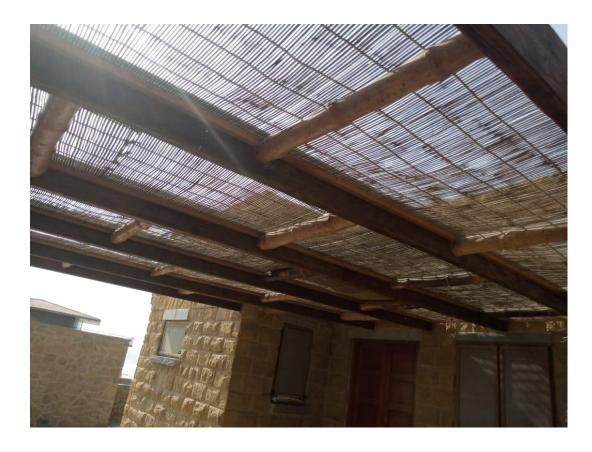
The roof was leaking from several points, new details had to be worked out to prevent any leakage

The entire roof was repaired, finished with solid water proofing treatment

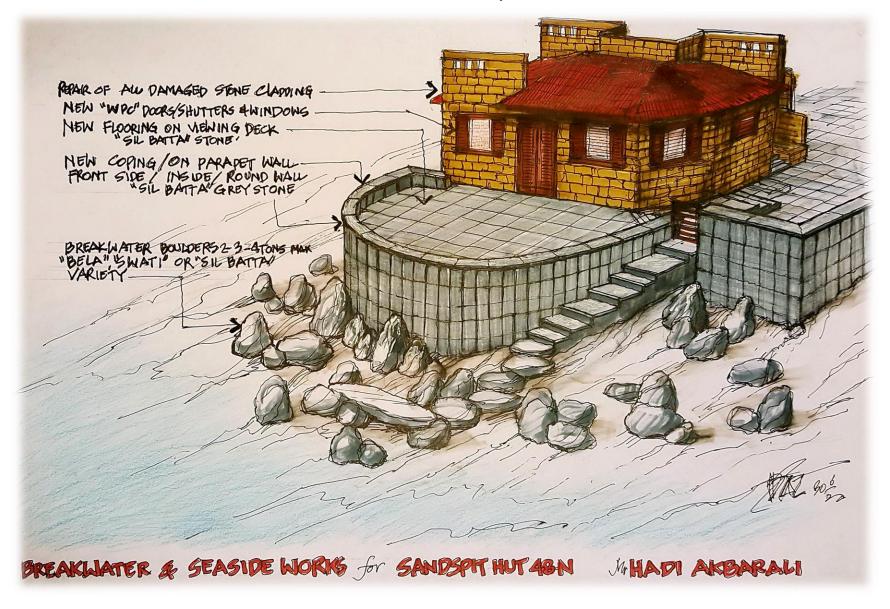
to reduce the impact of sea waves on the huts seaside

The Silbatta boulders weighing as much 5-6 tons were imported from Hub Chowki and placed with heavy duty cranes

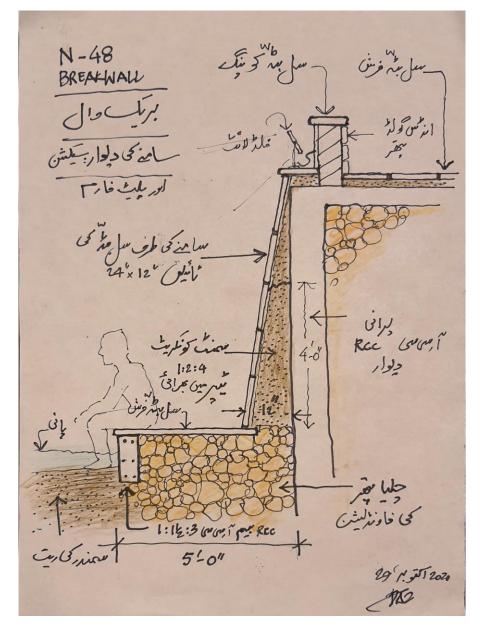
It was time to do the front wall of the deck which was most critical

The deck wall was clad with Silbatta stone
