First visit to the site showed that the hut was built a few years ago but was in a very bad shape

DAZDESIGN CONSULTANTS

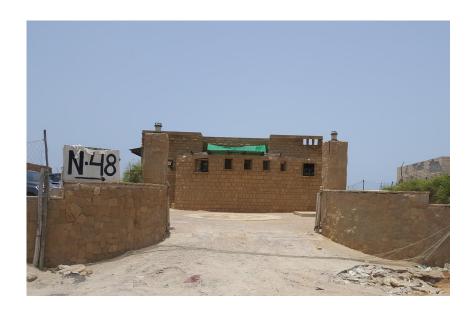
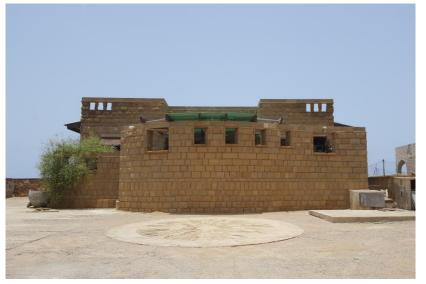
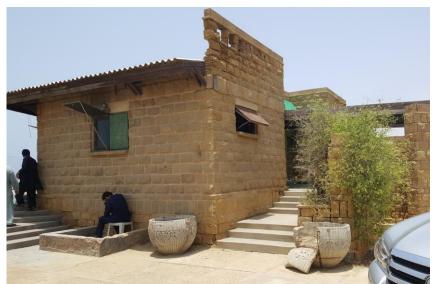
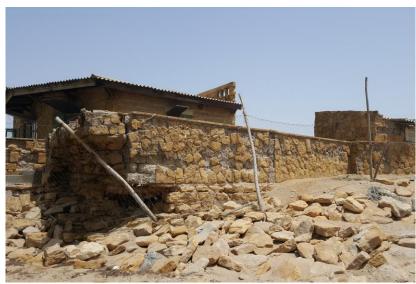
The basic structure was in place but the stone cladding had worn out considerably

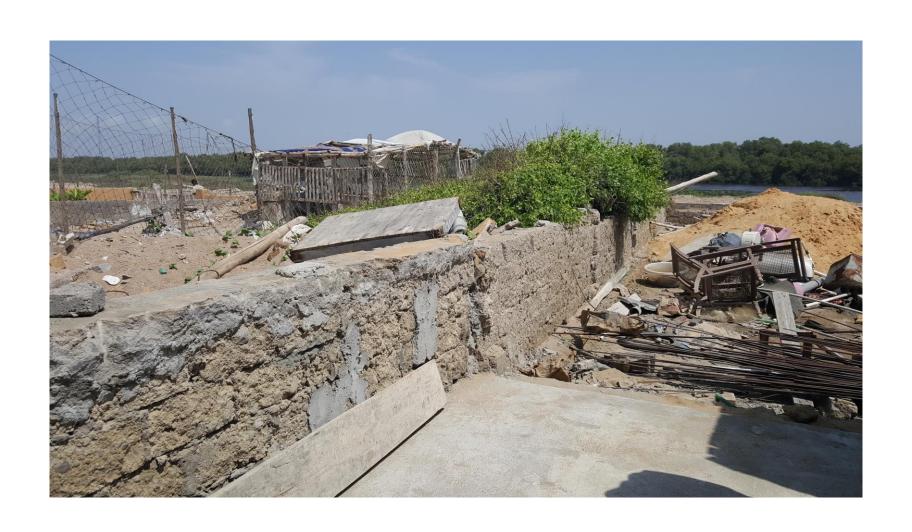
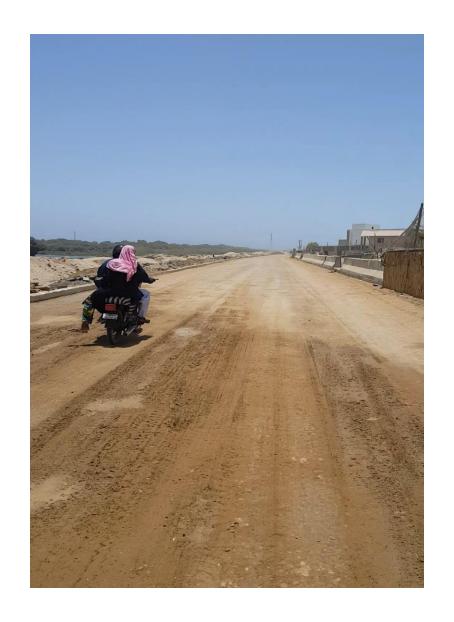
Most of the boundary wall of the hut was unfinished

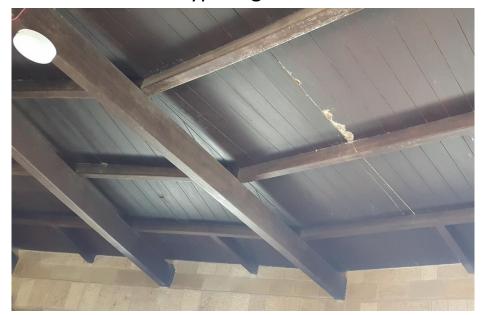
The entrance area had a typical green fabric shade

Lighting was poor, timber ceiling was painted brown

The green shade was removed from the entrance area with a new design introducing bamboo and 'Chikh' material

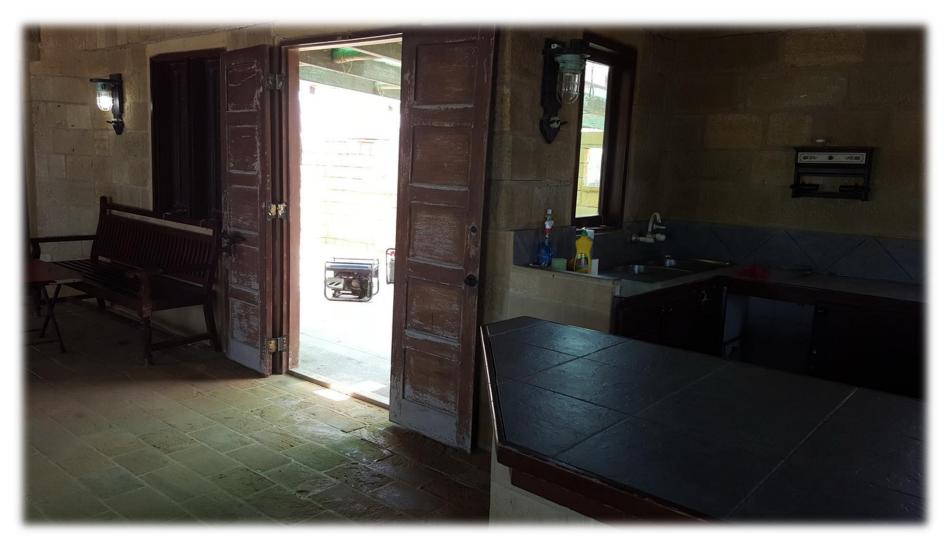
The timber work on the seaside was worst

The wear and tear in the interiors was less but feeling was of great disrepair, it was dark and gloomy, the woodwork was worn down

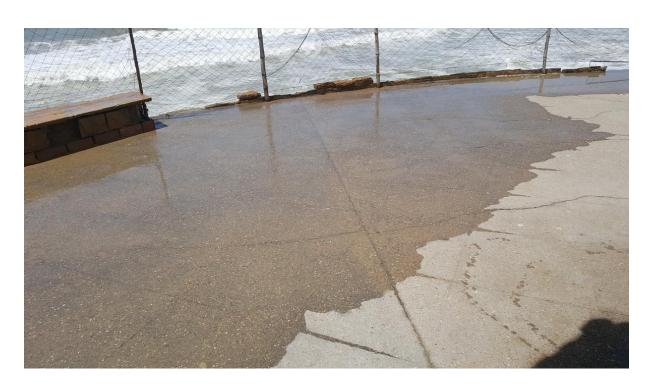
The sea water at times would flood the front deck and the compound area, despite the height of the deck

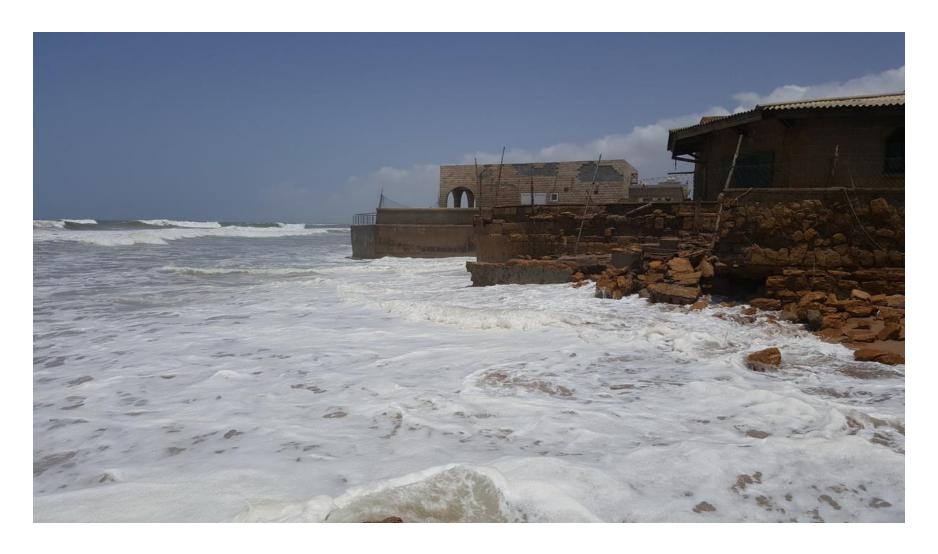
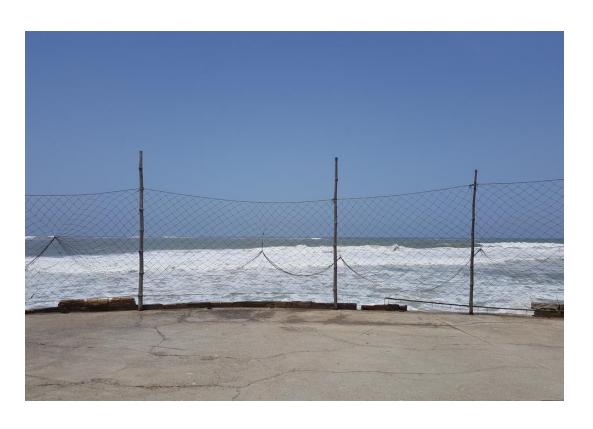
The waves had destroyed entire stone cladding on the hut. The materials crumbled under the might of the sea water

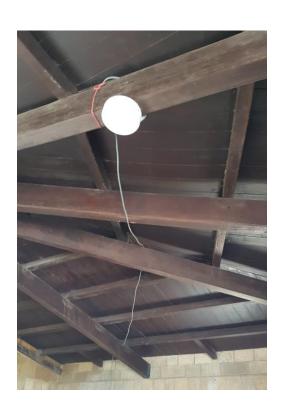
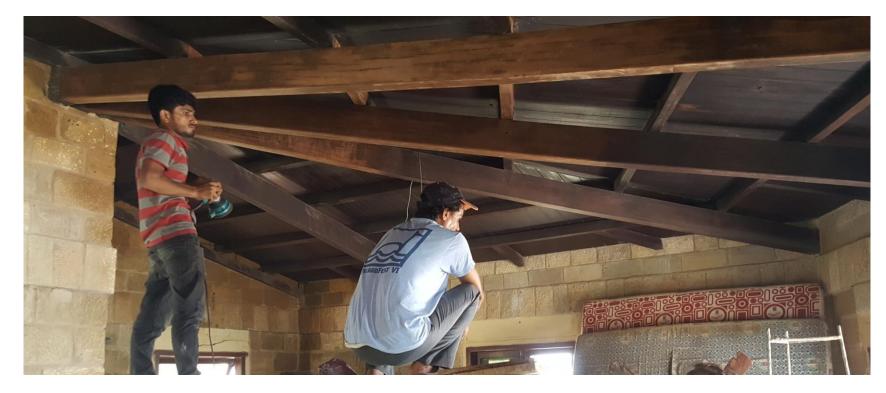
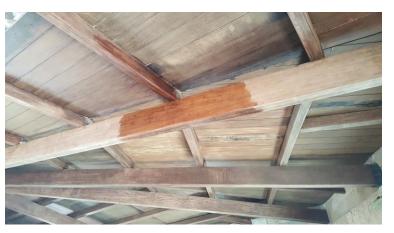
the results were excellent

We started the interior repair works with the Timber ceiling, which we thought could be salvaged by scrapping and repolish

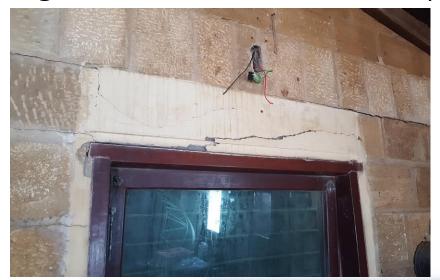
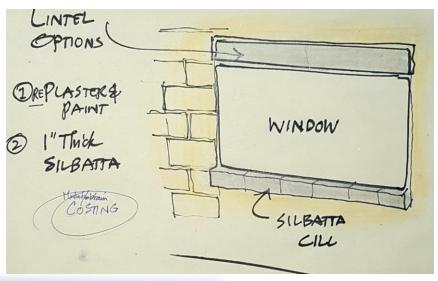
Next we took all the widows and woodwork. The RCC lentils were cracking, Sills were worn out, they were all replaced with Silbatta Stone

We proposed an extra cover for windows on the beach side with WPC and cement board. When the hut was not in use the timber windows would not wear out easily

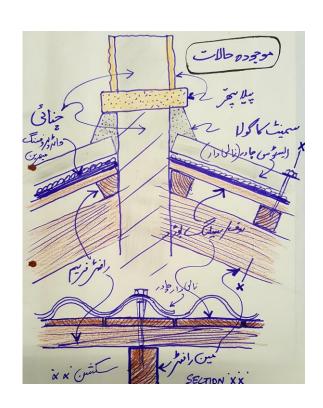
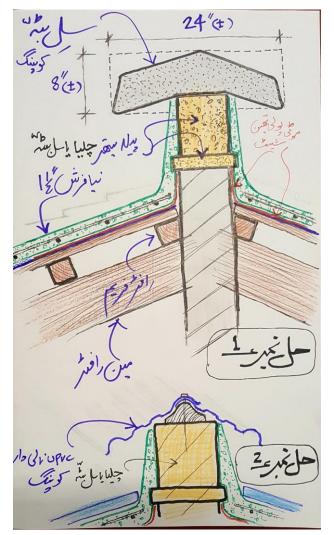
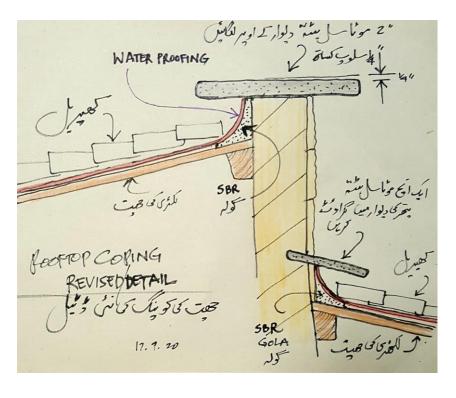
The roof was leaking from several points, new details had to be worked out to prevent any leakage

The entire roof was repaired, finished with solid water proofing treatment

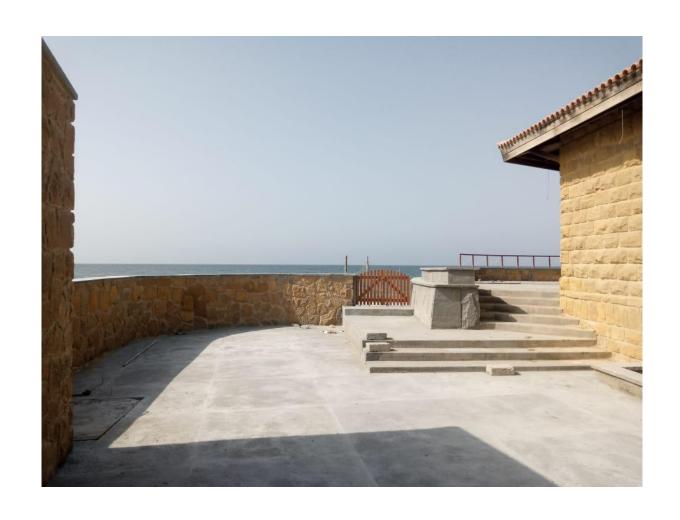
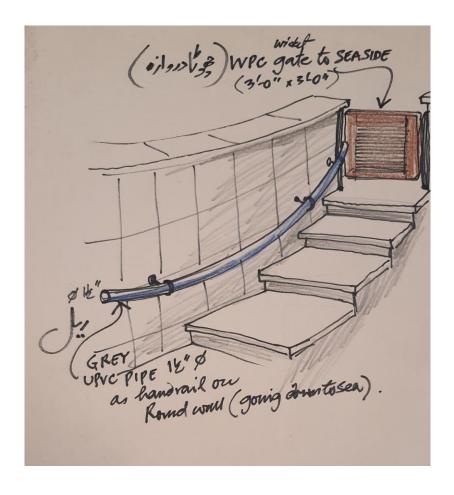
A low parapet wall was made on the deck with a small fence to safeguard the little ones

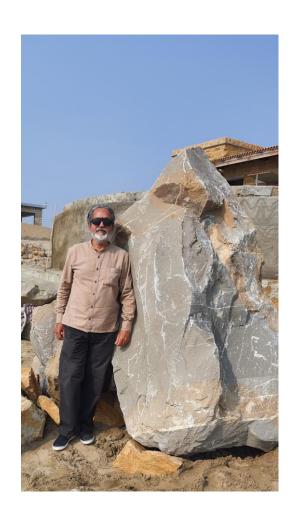
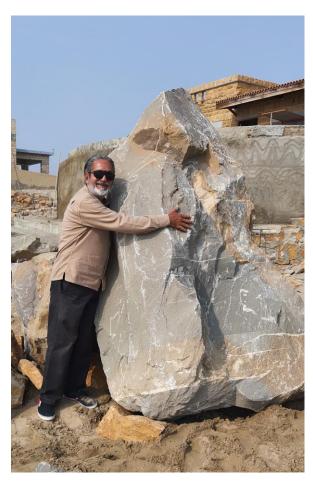
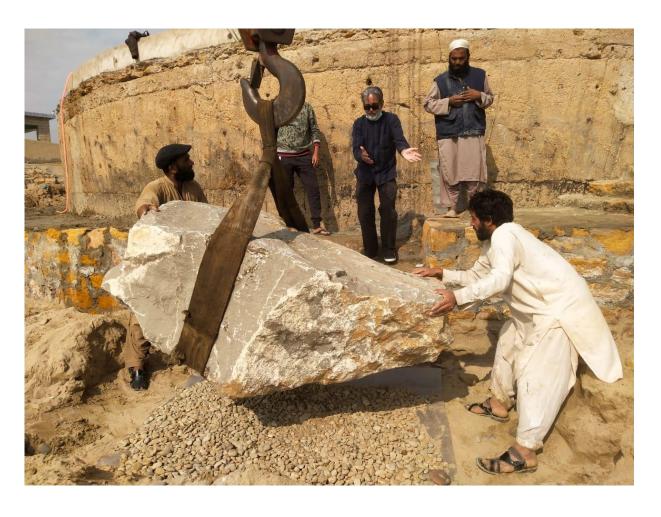
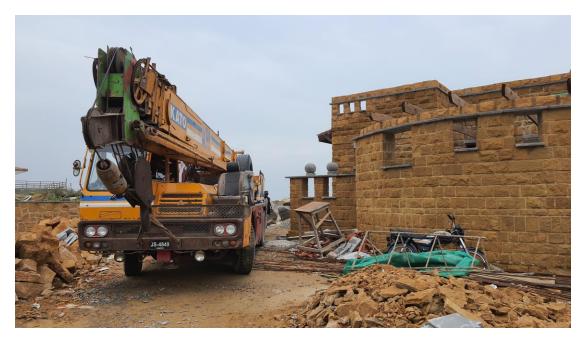
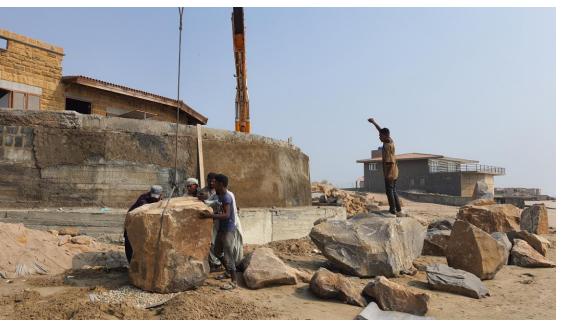
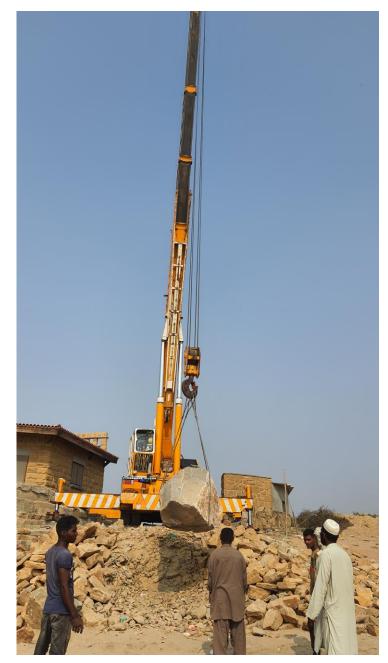
The Silbatta boulders weighing as much 5-6 tons were imported from Hub Chowki and placed with heavy duty cranes

We proposed large stone boulders to be placed strategically in front of the hut to reduce the impact of the waves

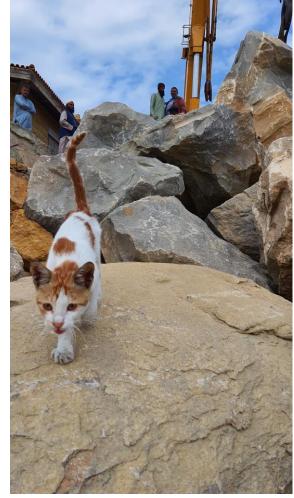
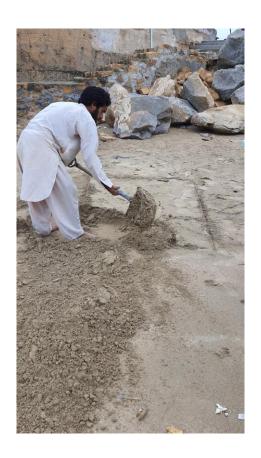
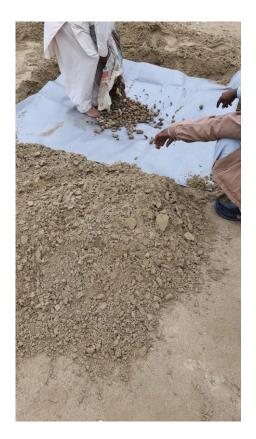
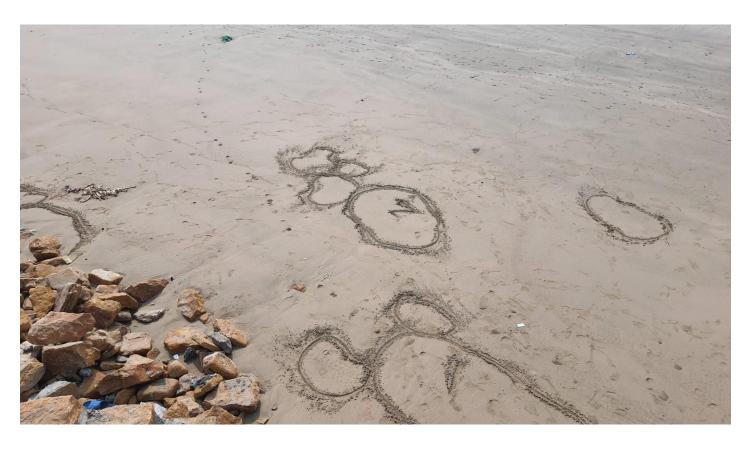
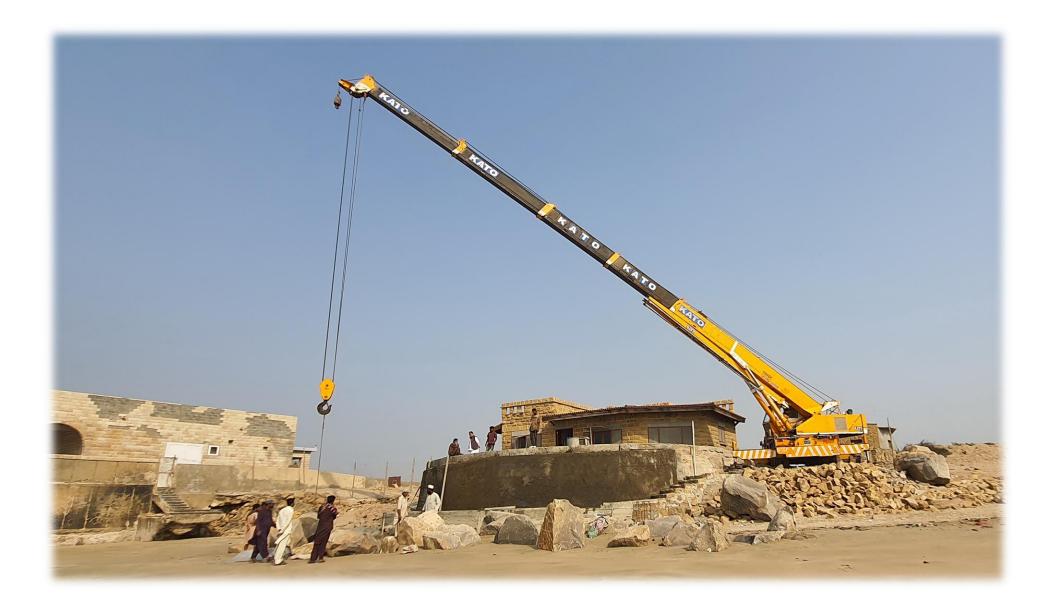
The placement of stone was marked out on the beach, and a base was prepared so that the stones would grip and sit firmly in the sand

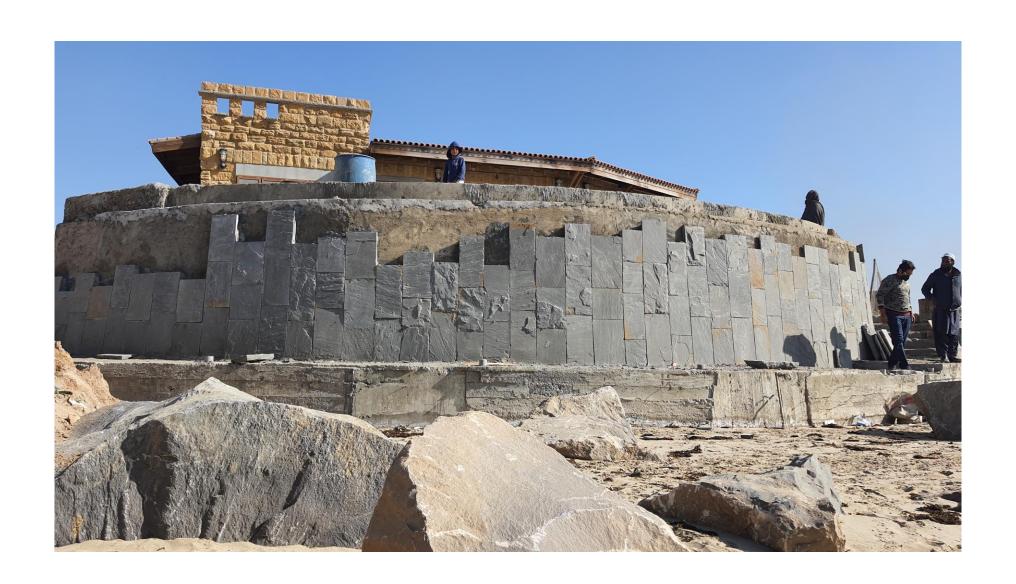
The deck wall was clad with Silbatta stone
